Silicon Precipitate Nodule-Induced Failures of MOSFETs

M. Johnson and D. Pote
Motorola, Inc.
Northbrook, IL

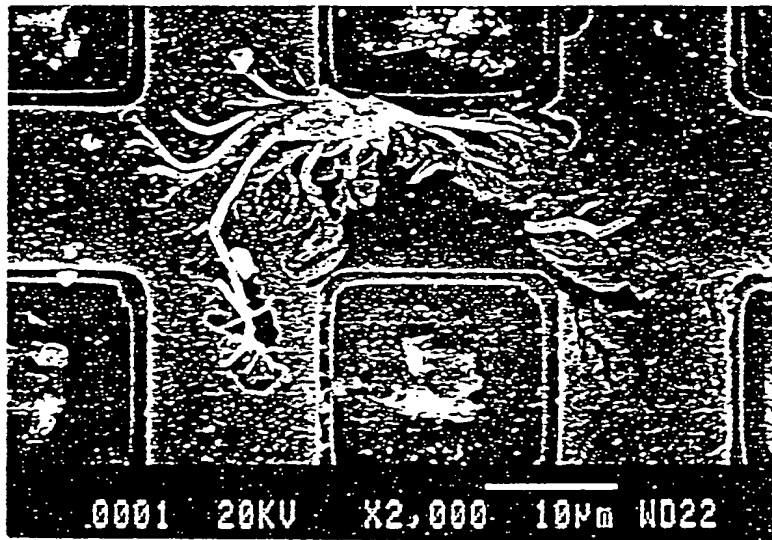
Figure 1: Unique pattern of fused polysilicon observed after removal of metallization and insulating oxide. (2000X)

Subsequent optical inspection identified an apparent electrical damage site under the wirebond. This damage was characterized by a central fused-site surrounded by multiple filaments (Figure 1). These filaments were dubbed "tentacles" or "roadkill" damage because of their appearance. SEM inspection of the same locations revealed surprisingly little

It is now believed that the filaments are the result of amplification of the damage at the original failure sites by the application of excess power during liquid crystal testing. A slightly higher level of power was necessary to counteract the obstructing heatsink effect of the relatively large wirebond. The heat generated at the damage site would initiate crystallization of the amorphous polysilicon depend-

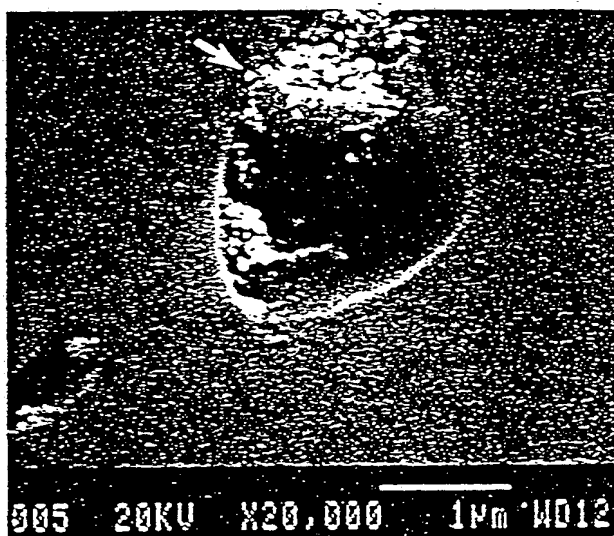
Figure 2: Small electrical damage site within chipet.
(25000X)

Cross-sections of failures revealed that the filaments were confined to the polysilicon layer, except at the central nucleus. At the nucleus, melted silicon and aluminum were observed extending vertically through the dielectric layer. On several devices where the filamentation was minimal, there was limited evidence of melting at the nucleus site and a small section or chip of the dielectric was missing (figure 2).

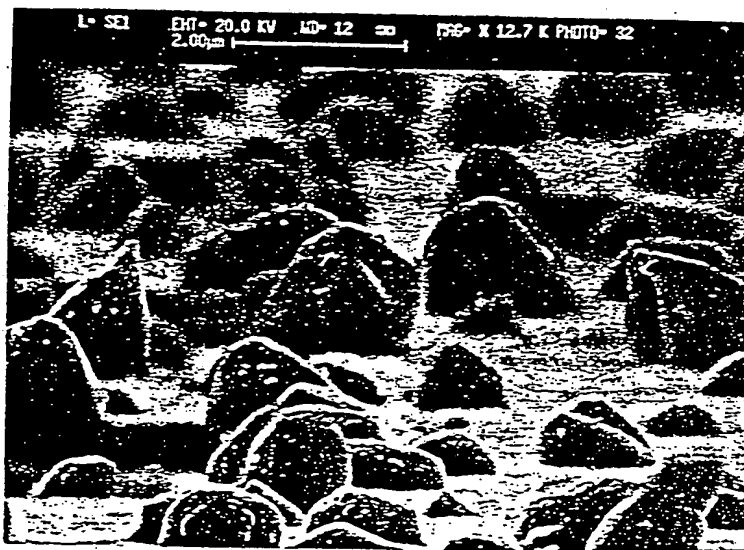
shape. Although they appear roughly circular under high power microscopy (400X), they are actually polyhedral and exhibit a wide range of aspect ratios (Figure 3). Typical height/width ratios range from 0.3 to 1.8.

Figure 3: Silicon precipitates (nodules) viewed from side exhibit variety of shapes and sizes. (12700X)

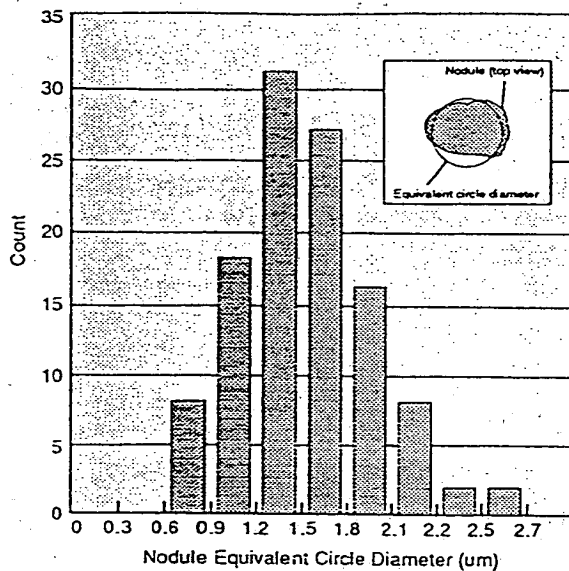
There were typically 50×10^3 to 100×10^3 nodules per square millimeter in the subject devices. In general, the nodule density -- the number of nodules per unit surface area -- was inversely proportionate to the average size of the nodules. That is, when the nodules were large, there tended to be few of them. Conversely, when the nodule count was high, they tended to be small. Figure 4 shows a typical histogram of nodule sizes produced by an image analysis

Figure 4: Example distribution of nodule sizes

system capable of performing feature counting. Unfortunately, easily measured characteristics of the nodules, such as density (count/area), could not be easily correlated to failure rate. It is hypothesized that the probability of failure is governed by extreme value statistics (weakest link theory), and detailed info regarding the shape and size of the nodules can be difficult to obtain on a large number of samples.

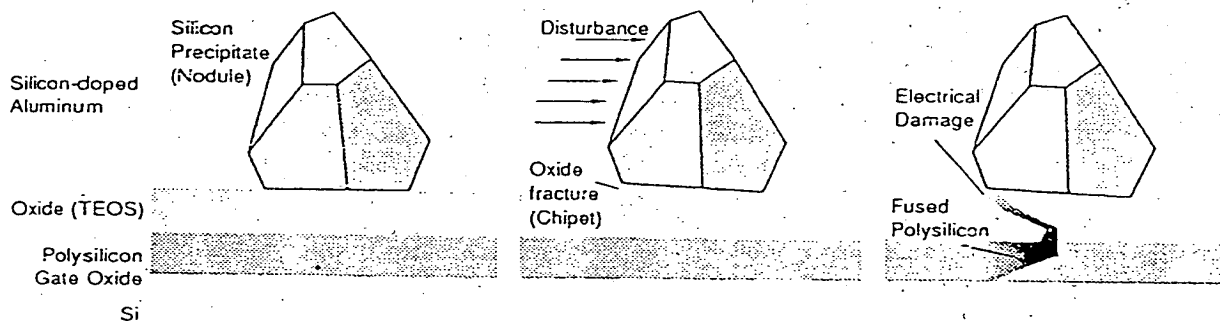
The adhered nodules could be removed quite easily; gentle brushing of a few fibers from a cotton swab was sufficient to disturb them. When these well-adhered nodules are displaced, they often take with them a portion of underlying oxide, forming a distinctive, football-shaped chip-out, or *chipet* (Figure 5). The depth of the resulting chipet was roughly equal to half the length of the chipet's minor axis, itself related to the area of contact between nodule and oxide.

In the MOSFET devices the lateral displacement of the nodules occurs during the wirebonding process. The cavity formed by the chipet is immediately filled with aluminum. These chipets, during

Figure 5: Movement of nodule results in fracture of underlying oxide.

electrical stress, appear to act as weak points in the insulating oxide. If the chipet is sufficiently deep to fully compromise the thickness of the dielectric oxide, a linear resistive short between the source metallization and gate polysilicon results. However, if the root only partially compromises the dielectric, a leaky diode-like characteristic results.
